**SEISMIC CHARACTERIZATION STUDY OF THE  
ADVANCED INERTIAL TEST LABORATORY (AITL)  
REPORT**

**PREPARED BY  
746TH TEST SQUADRON  
46TH TEST GROUP  
HOLLOMAN AFB NM 88330-7850**

**8 DECEMBER 2008  
STUDY REPORT**

CIGTF-SR-08-01  
December 2008

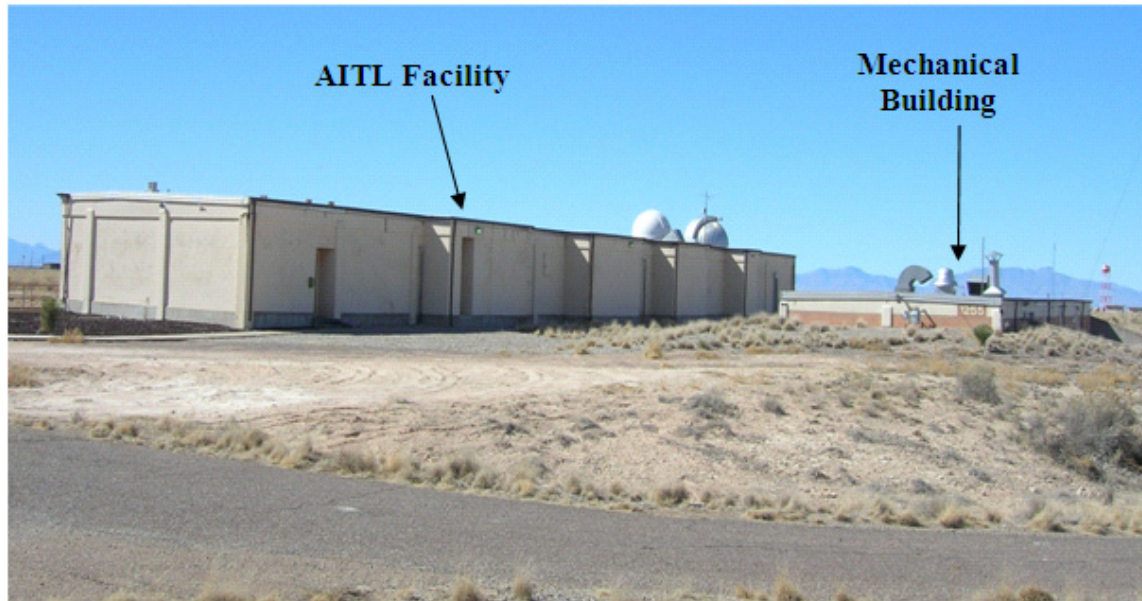
**Figure 1. The Advanced Inertial Test Laboratory (AITL)**

**1.1 Background.** The Advanced Inertial Test Laboratory (AITL), figure 1, is the most seismically quiet test facility in the nation. The seismic characteristics of AITL are due, in part, to its location in the Tularosa Basin, a naturally seismically quiet part of the nation away from urban and oceanic generated disturbances. Seismically quiet testing has been a core test capability of the 746th Test Squadron and has been recently re-identified as a core business objective of the squadron. This decision was supported by the 46th Test Group. Through the 1970s until the mid-1980s, AITL was used extensively for testing highly accurate inertial components of the Department of Defense's (DoD) intercontinental ballistic missile programs. Since the mid-80s, the Hubble Space Telescope program was the only inertial program demanding a low-seismic test environment.

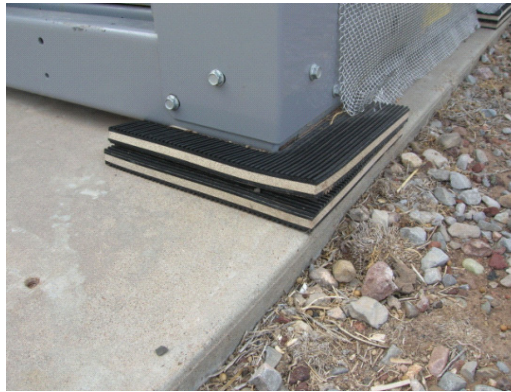
**Figure 7. Chiller Passive Isolator**

From an examination of the isolation pads under the chiller, figure 7, it is evident that the passive isolation material presently installed under the air conditioning chiller is not being fully utilized. Because the material has curled up, the weight is not evenly distributed across its surface. This results in the compression of only the material directly under the weight, thereby reducing the full isolation capability of the material. Additionally, vibrations from the chiller can be felt by simply placing one's hand on the cast-iron pipes where they enter and exit the building.

**2.3.2.4 Recommendation.** Improve the isolation of the ESE in order to reduce the seismic disturbances being coupled into the Room 13 test pad (R1).

Replace the current isolation material and place aluminum plates between the top of the isolation material and the chiller base. New isolation material has been identified that provides almost double the current isolation. If it is determined that further improvement is required, beyond that which will be afforded by the recommendation above, ways could be developed to replace sections of the cast iron pipe carrying the chilled water into and out of the Mechanical Building with soft flexible piping. This will isolate the vibrations close to their source and prevent the disturbance from being transferred into the walls or other parts of the facility.

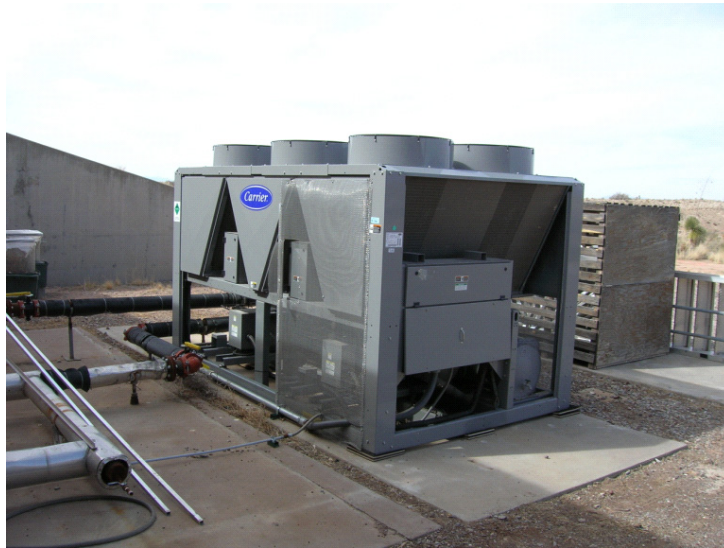
Figure A-1. Refrigerated Air Conditioner (Chiller)

When AITL was constructed, the environmental support equipment (ESE) was mounted on vibration isolators and housed in a separate building, the Mechanical Building, in order to minimize the effects its operation had on the test environment. After the mid-80s, when the workload in the building decreased, replacement ESE was not properly isolated. In Dec 05, a preliminary study was completed to assess the existing seismic environment on the isolation pad in Room 13 of AITL (reference 1). This study revealed considerable degradation in the seismic environment. Since that time, a new refrigerated air conditioner (chiller) (appendix A, figure A-1) and a new air compressor (appendix A, figure A-2) were installed.
